Manhole Inspection Summary

Manhole # S35G__032MH

Location Address: **120 E LOMBARD ST** Cross Street: **N CALVERT ST**

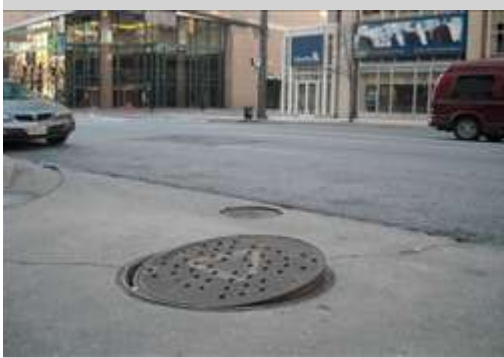
Location View

IN ALLEY OFF E LOMBARD ST

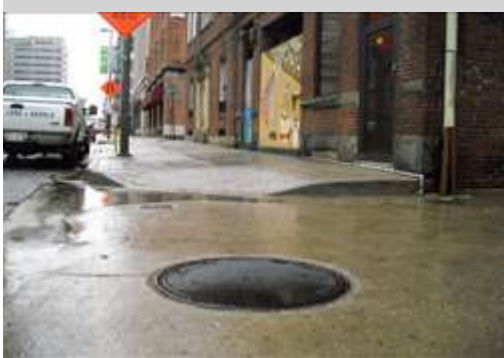
NEW LID

REPLACED PREVIOUSLY CRACKED
STORM DRAIN LID WITH NEW
SANITARY LID

Comments **PREVIOUS LID WAS A BROKEN VENTED STORM DRAIN LID. BROKE OPEN AND REPLACED WITH A NEW SANITARY LID BY REI. INSPECTION COMPLETE.**

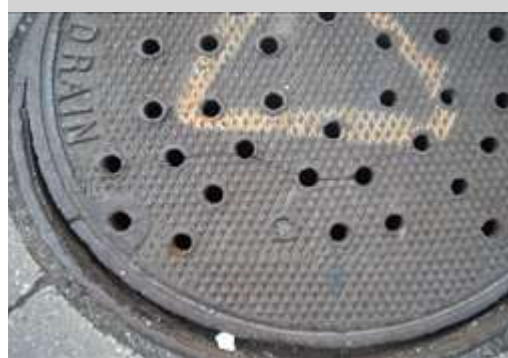
PRIOR LID BROKEN

PREVIOUS LID WAS VENTED STORM
DRAIN LID WITH CRACK

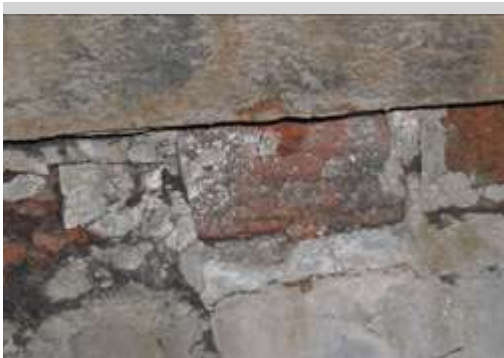
Defect 4

Corbel Material: **Brick** ☐ Parged Type: **Concentric/Eccentric**
Condition: ☐ Sound ☒ **Cracked** ☐ Root Intrusion ☐ Loose Brick ☒ **Deteriorated**
Infiltration: ☒ None ☐ Joint ☐ Cracks ☐ Mortar ☐ Roots ☐ Wall

CORBEL CRACKED AND DEGRADED

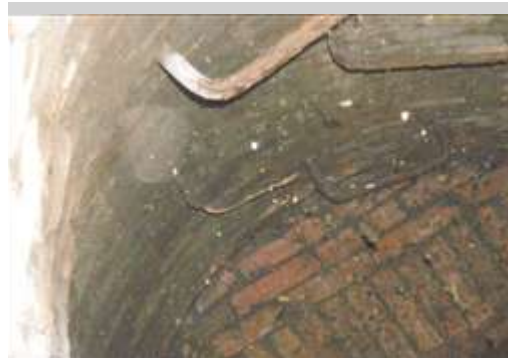
Defect 3

Steps Count: **6** Missing: **1** ☒ **Corroded**

CORRODED STEPS

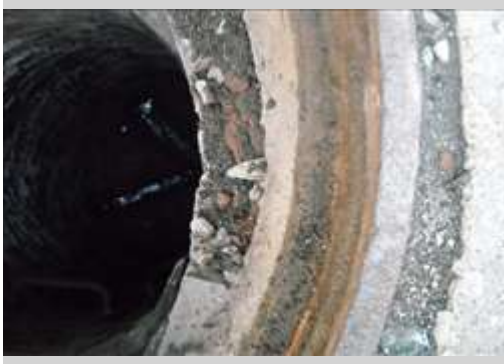
Defect 2

Frame Offset: **2** (in.) Condition: ☐ Sound ☒ **Cracked** ☐ Leaks

FRAME OFFSET 2" IS CRACKED AND DEGRADED

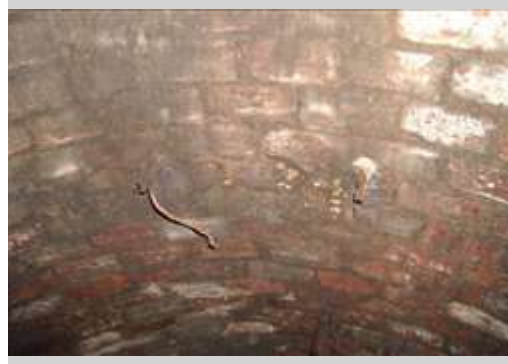
Defect 1

STEP HAS CORRODED AWAY

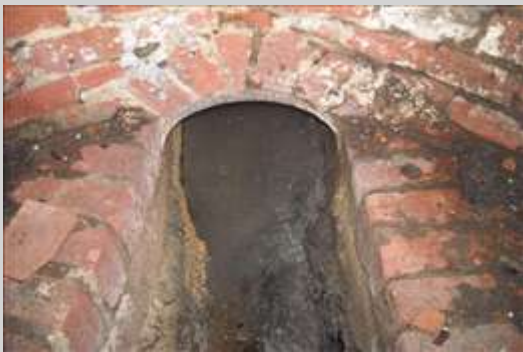
12 O'Clock Outflow

Pipe Height: **12** (in.) Rod and Bar (Angled)
Pipe Material: **Clay** ☐ Pipe Lined
Invert Depth: **12.00** (ft.) Flow Characteristics: **Slow**
Deposits: ☒ None ☐ Mud ☐ Sludge ☐ Debris ☐ Grease
Silt Depth: **0** (in.) Deposits Extent:
Infiltration: **None** Pipe Seal Cond: **Sound**

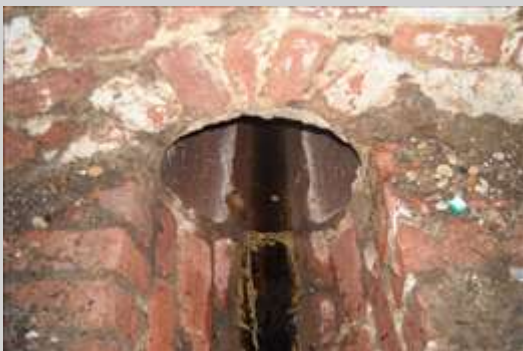
6 O'Clock Inflow

Pipe Height: **12** (in.) Rod and Bar (Angled)
Pipe Material: **Clay** ☐ Pipe Lined
Invert Depth: **11.37** (ft.) Flow Characteristics: **Slow**
Deposits: ☒ None ☐ Mud ☐ Sludge ☐ Debris ☐ Grease
Silt Depth: **0** (in.) Deposits Extent:
Infiltration: **None** Pipe Seal Cond: **Sound**

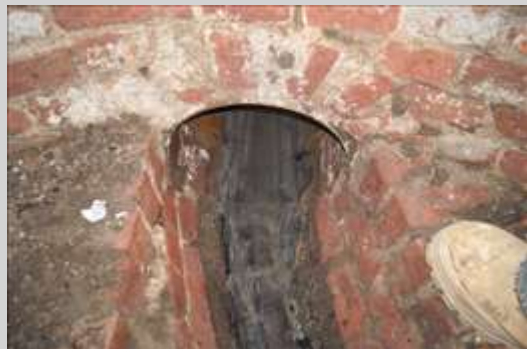
9 O'Clock Inflow

Pipe Height: **12** (in.) Rod and Bar (Angled)

Pipe Material: **Clay** ☐ Pipe Lined

Invert Depth: **11.39** (ft.) Flow Characteristics: **Slow**

Deposits: ☒ None ☐ Mud ☐ Sludge ☐ Debris ☐ Grease

Infiltration: **None** Pipe Seal Cond: **Sound**
